Manhole Inspection Summary

Manhole # S43I2_009MH

Location Address: **1200 West Bay Ave.**

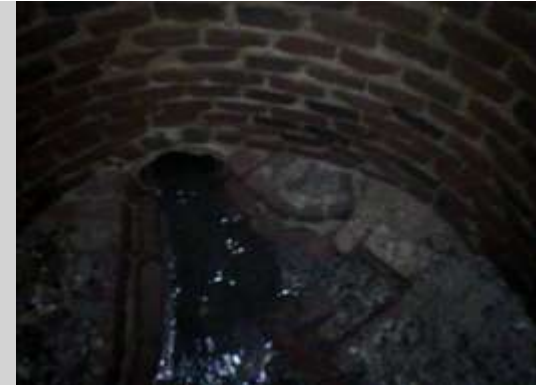
8 in. Circular Gravity Sewer
Pipe Out @ 12 O'Clock

Pipe Height: **8.4** (in.) Rod and Bar (Angled)
Pipe Material: **Clay** ☐ Pipe Lined
Invert Depth: **25.40** (ft.) Flow Characteristics: **Slow**
Deposits: ☒ None ☐ Mud ☐ Sludge ☐ Debris ☐ Grease
Silt Depth: (in.) Deposits Extent:
Infiltration: **None** Pipe Seal Cond: **Sound**

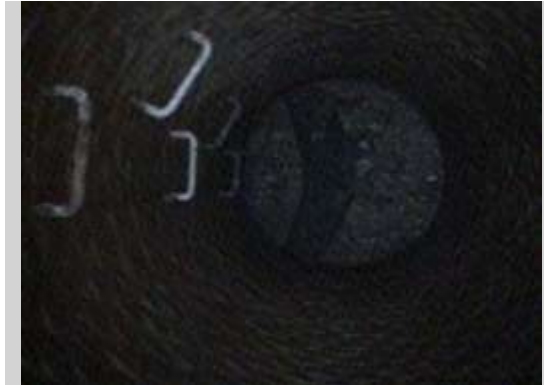
12 O'Clock Outflow
Pipe Out @ 12 O'Clock

Drop: **None**

Connects To: **Manhole**
